*Application of Google Street View Application for Footpaths' Inspection in
Nakhonratchasima City Municipality, Thailand*

Pornthip Ueathamataworn, Rajamangala University of Technology Isan,
Thailand

The IAFOR International Conference on Sustainability, Energy & the Environment –
Hawaii 2020
Official Conference Proceedings

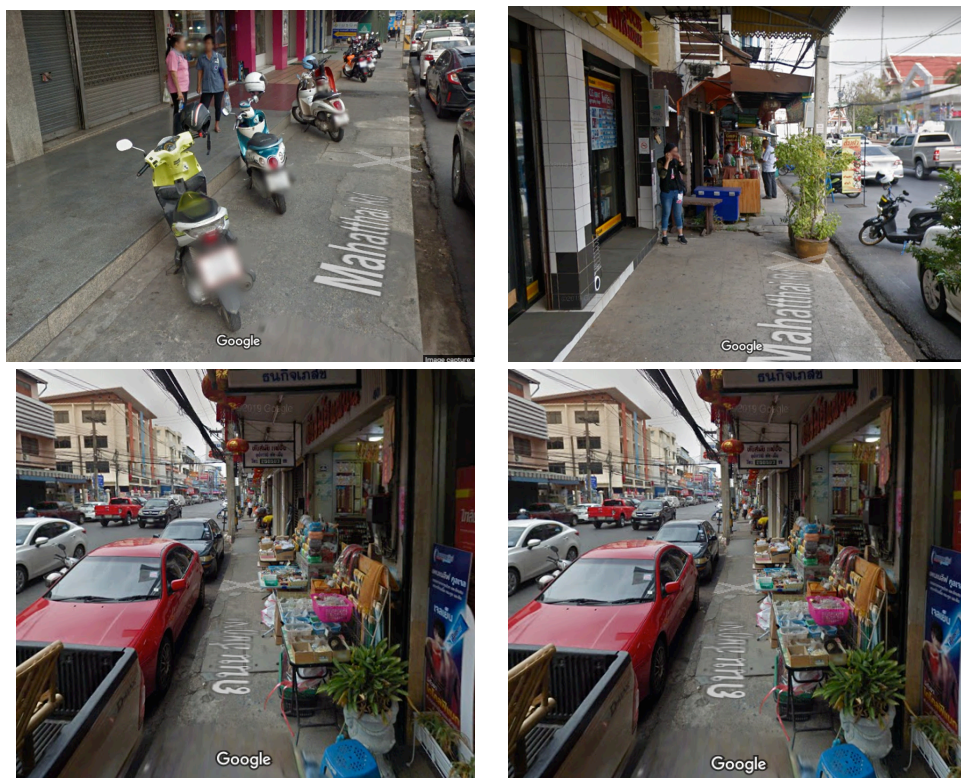
Source: Google Street View

It found that all inspected 5 routes were lacked of obstacles arrangement. There were many shops on the footpath. Moreover, there were some motorcycle parked on the footpath as well as a show in the sample figure 3.

Figure3: Lack of protruding objects arrangement sample pictures. Moreover, footways are not protective rails for disables people as show in Figure 4.

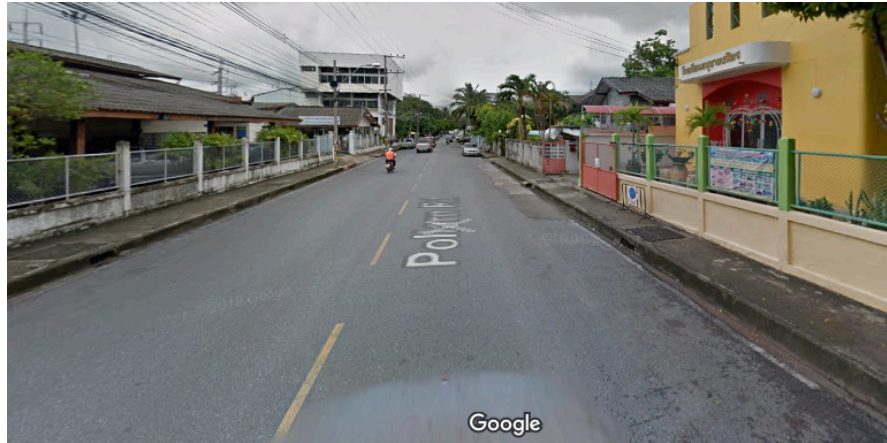
Source: Google Street View
Figure3: Lack of protective rail for footpath.
