Application of Google Street View Application for Footpaths' Inspection in Nakhonratchasima City Municipality, Thailand

The IAFOR International Conference on Sustainability, Energy & the Environment –
Hawaii 2020
Official Conference Proceedings

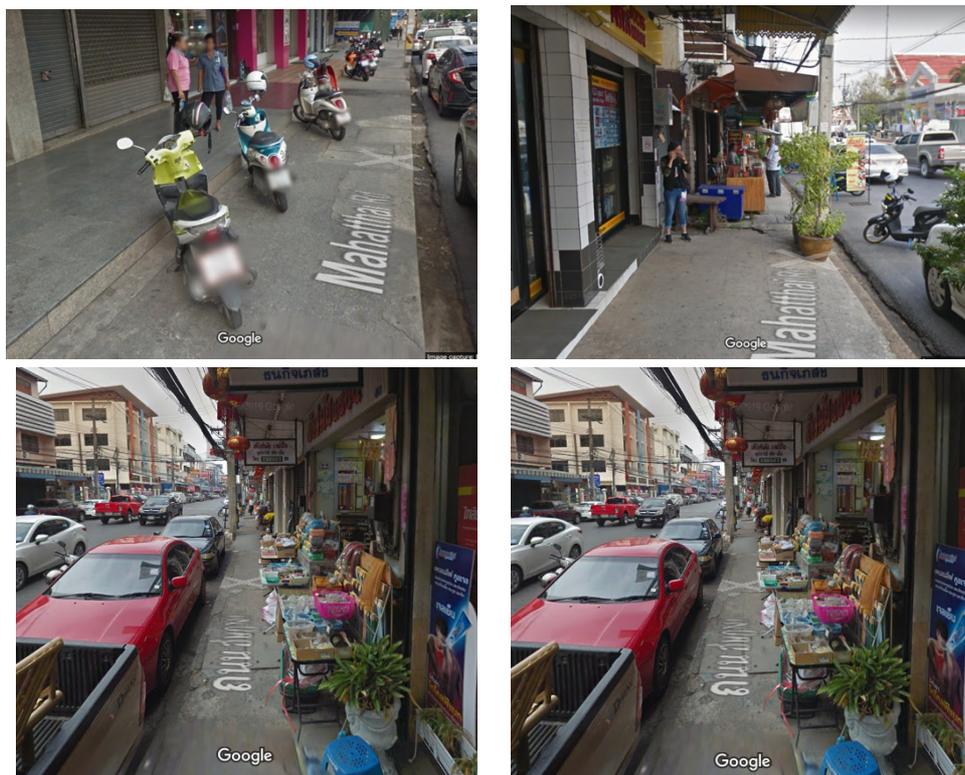
It found that all inspected 5 routes were lacked of obstacles arrangement. There were many shops on the footpath. Moreover, there were some motorcycle parked on the footpath as well as a show in the sample figure 3.

Figure3: Lack of protruding objects arrangement sample pictures. Moreover, footways are not protective rails for disables people as show in Figure 4.

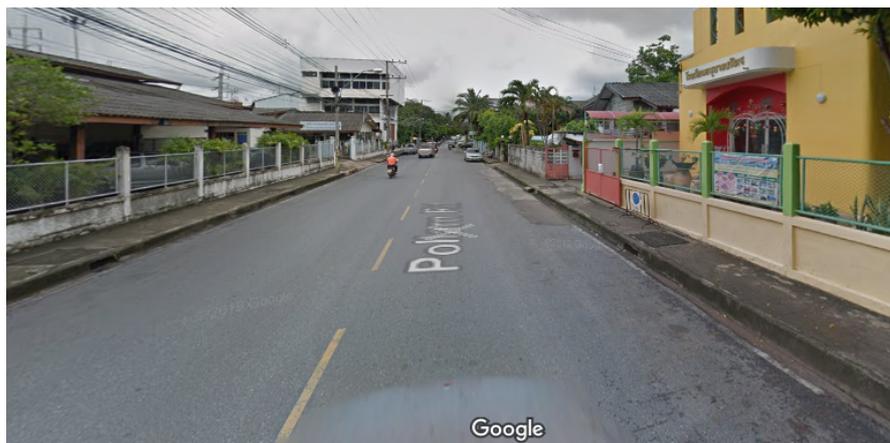
Source: Google Street View
Figure3: Lack of protective rail for footpath.
